THE  
ECCLESIASTICAL  
ARCHITECTURE  
OF SCOTLAND

FROM THE EARLIEST CHRISTIAN TIMES TO THE  
SEVENTEENTH CENTURY

BY  
DAVID MACGIBBON AND THOMAS ROSS  
AUTHORS OF "THE CASTELLATED AND DOMESTIC ARCHITECTURE OF SCOTLAND"

VOLUME ONE

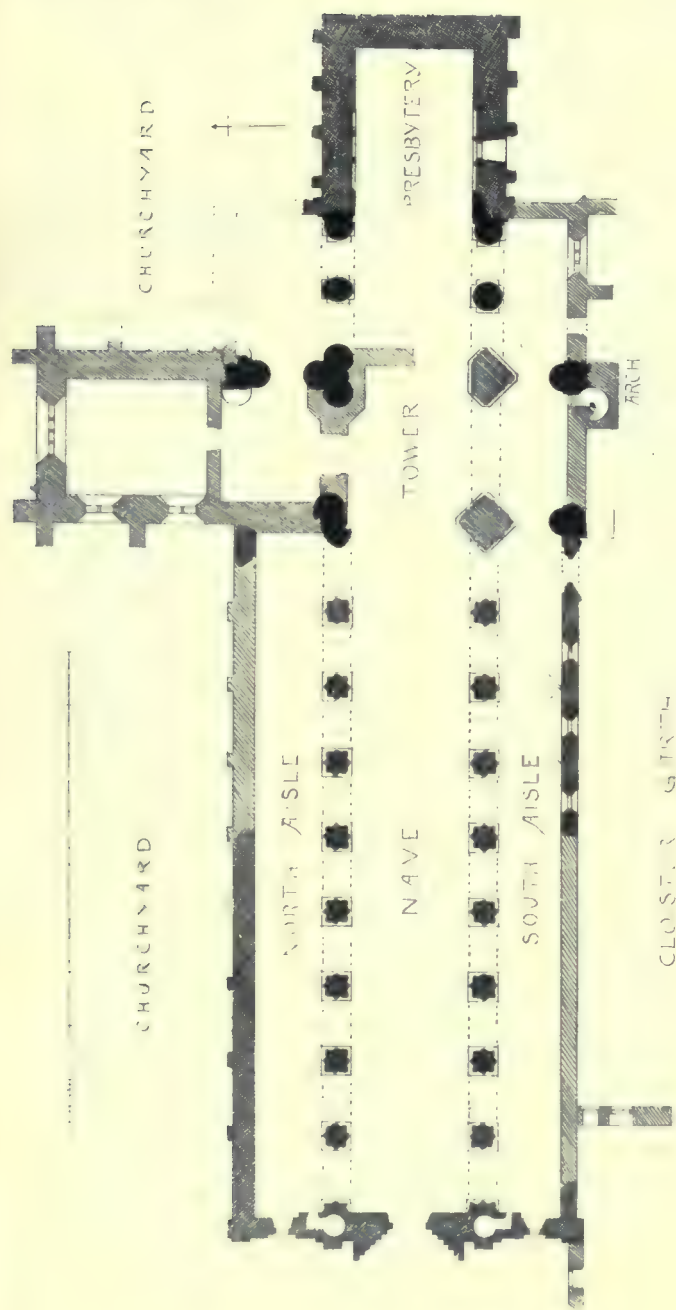
FIG. 363.—Jedburgh Abbey. Plan.

The church (Fig. 363, Plan) consists of a choir, with side aisles extending eastwards for two bays, beyond which was an aisleless presbytery, the east end of which is demolished; a nave of nine bays, which had vaulted side aisles (now greatly destroyed); a central crossing, with a square tower above; a north transept, well preserved; and a south transept, of which the south end is destroyed.

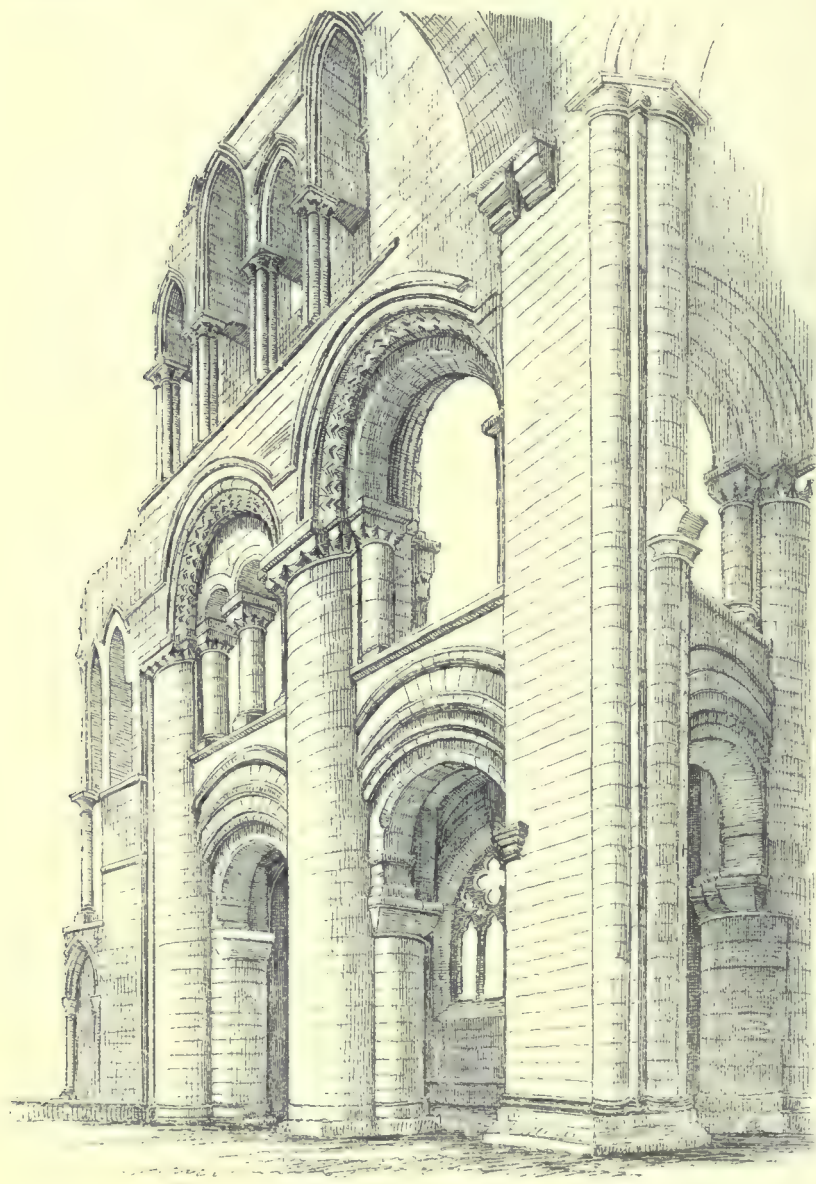
FIG. 364.—Jedburgh Abbey. South Side of Choir.

The choir and presbytery, as already mentioned, have been greatly damaged, and the east end is destroyed. It has been suggested that the choir may have terminated with an eastern apse, but of this there is no proof. What survives (Fig. 364) consists of the two bays next the crossing, the lower portions of which are in the Norman style. The main piers have the peculiarity of being carried up as massive cylindrical columns to the height of the arch over the triforium. This arrangement is unique in Scotland, but is not unknown in England. A somewhat similar design is carried out at Gloucester Cathedral, where the massive cylindrical piers are of great height, but they are not divided into two stories. At Romsey Church, Hampshire, however, the same arrangement occurs as at Jedburgh (Fig. 365), the tall round piers being divided by an intermediate arch, which supports the upper gallery or triforium.

About half-way up the south-east pier, rebuilt by Abbot Hall, the springer of an arch (see Fig. 364) may be seen projecting to the west. Abbot Hall has evidently intended to throw an arch across the transept at this point, but Abbot Cranston changed his plan, and the arch was not carried out. The mouldings of the portions executed by the two abbots differ in their respective parts of the structure.

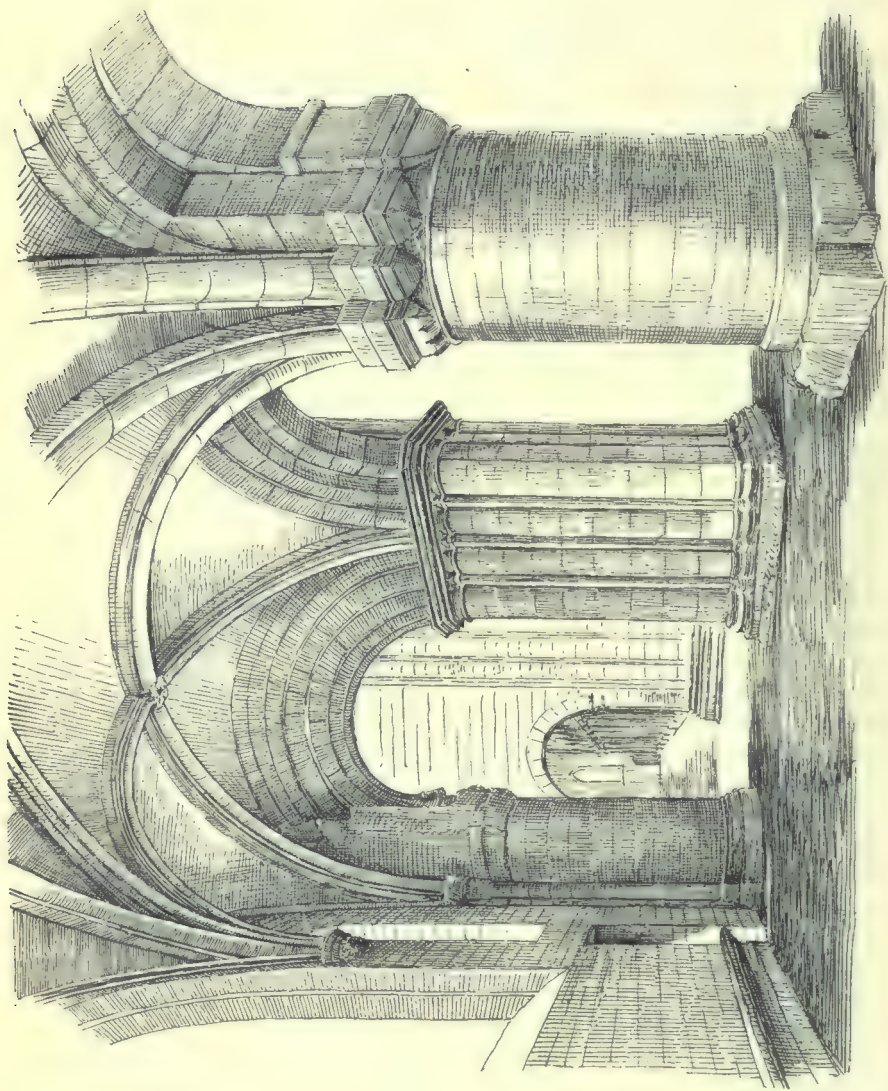
FIG. 366.—Jedburgh Abbey. South Aisle of Choir, looking West.

At Jedburgh the lower story has the round arch and vaulting ribs supported on corbels (Fig. 366), projected from the round face of the piers.

A similar plan is adopted at Romsey and also at Oxford Cathedral. The upper or triforium arch at Jedburgh is round and moulded, and contains a well wrought chevron ornament. It rests on large caps of the divided cushion pattern. The main arch is formed into two openings by a central round shaft and two half round responds, with massive cushion caps carrying plain arches.

shafts (see Fig. 366), with a moulded cap of late date. The upper mouldings of the cap form a continuous straight line, while the bells of the caps are broken round the shafts; a style of cap common in Scotland at the end of the fifteenth century.

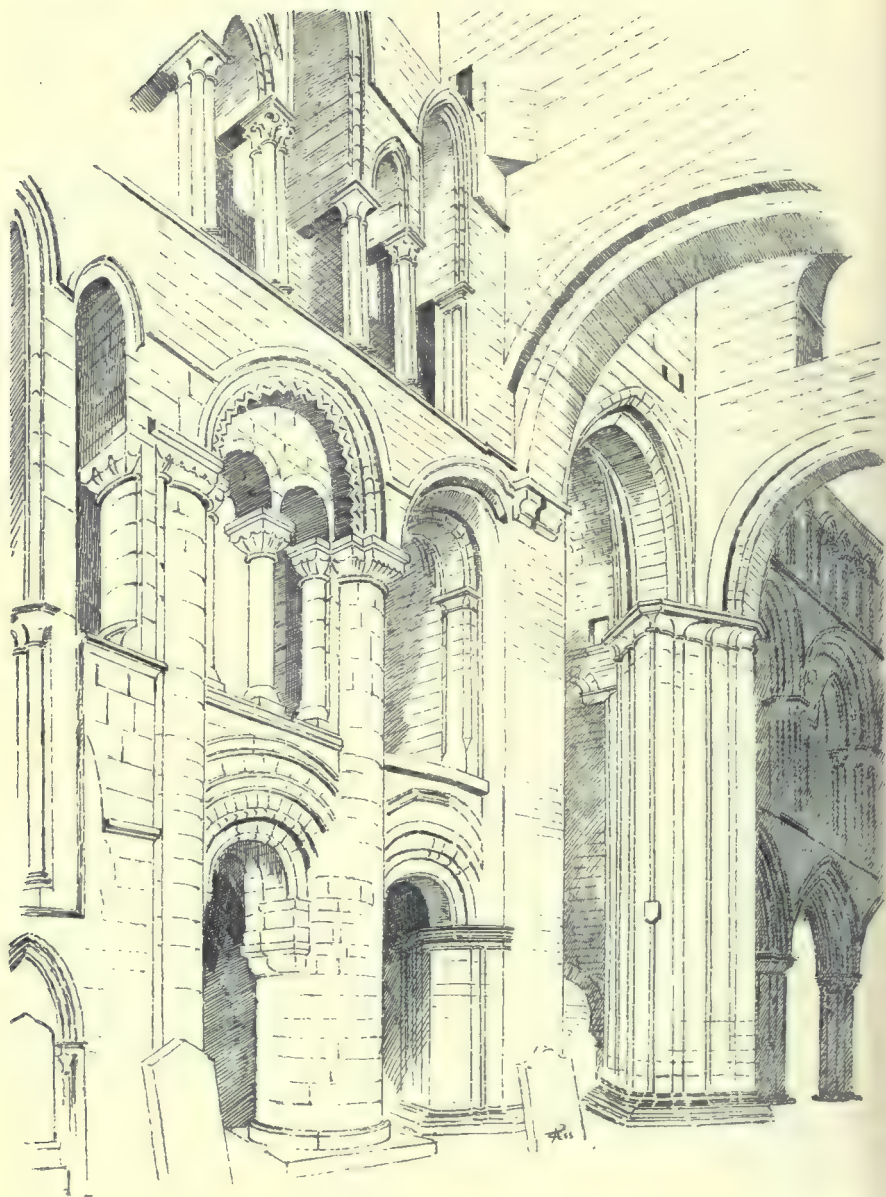
FIG. 367.—Jedburgh Abbey. South Side of Choir and Crossing.

At the time when the transitional clerestory was erected, the eastern part of the choir appears to have been built, as the remains of two lofty pointed windows are preserved to the east of the cylindrical piers (Fig. 367). These lofty arches have sprung from shafts with Transition caps at the level of the triforium floor, and a pointed arcade beneath seems to have been continued round the east end of the choir and presbytery.

choir and south transept (Fig. 367), and the junction of the new work with the old is very apparent. This pier has clearly been rebuilt. It is plain next the crossing, but next the aisle it consists of a series of

This pier and the south aisle of the choir beside it appear to have been restored by Abbot John Hall (appointed 1478), whose name occurs on the pier and on one of the bosses. The south-west pier of the crossing has also been rebuilt. This work was carried out by Abbot Thomas Cranston (appointed 1482). On a shield on this pier (see Fig. 367) are carved the arms and initials of Abbot Cranston—three cranes and two pastoral staves—saltierwise.

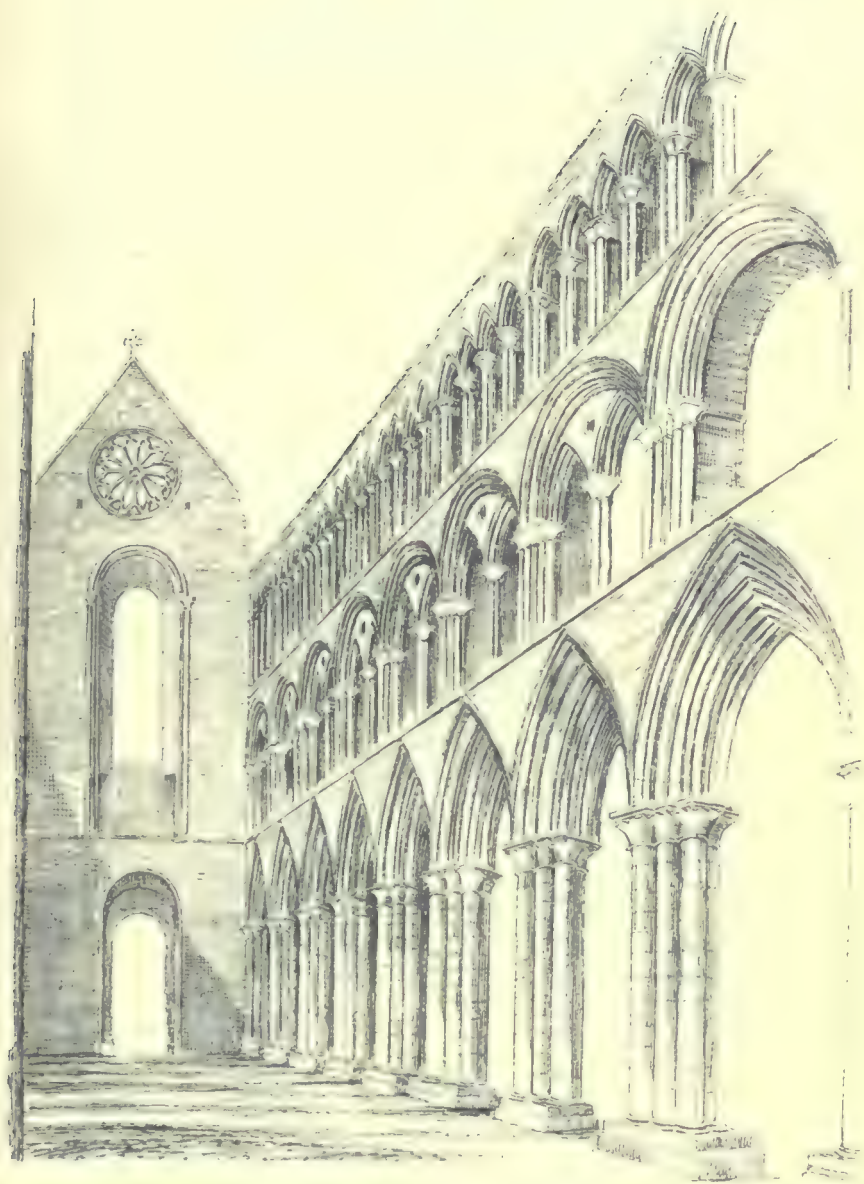
FIG. 368.—Jedburgh Abbey. The Nave, looking West.

It is divided into nine bays, each of which (Fig. 368) comprises a main arch resting on clustered piers, a triforium with one round arch containing two pointed arches, and a clerestory forming a continuous arcade, with four pointed arches in each bay. The main clustered piers contain (Fig. 369) four principal shafts at the angles and four intermediate shafts between them. The former are brought to a point on the face, the latter are flatter. The caps are simple and of an ordinary transitional

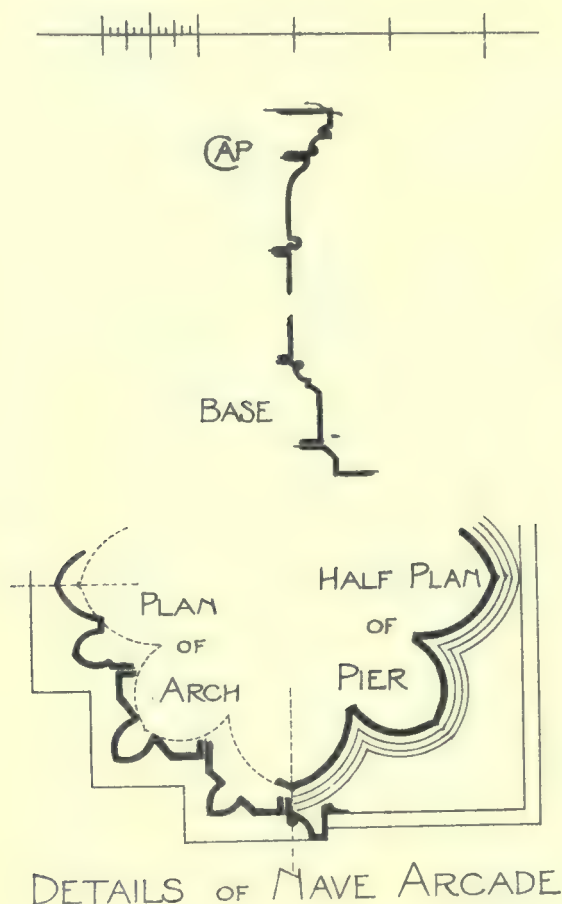
FIG. 369.—Jedburgh Abbey. Details.

form (Fig. 370), each with a square abacus. The bases are also simple and stand on a massive square plinth, a feature not uncommon in Norman work. The arches of the main arcade are somewhat acutely pointed, and the mouldings are bold, and resemble first pointed work. (See Fig. 369.)

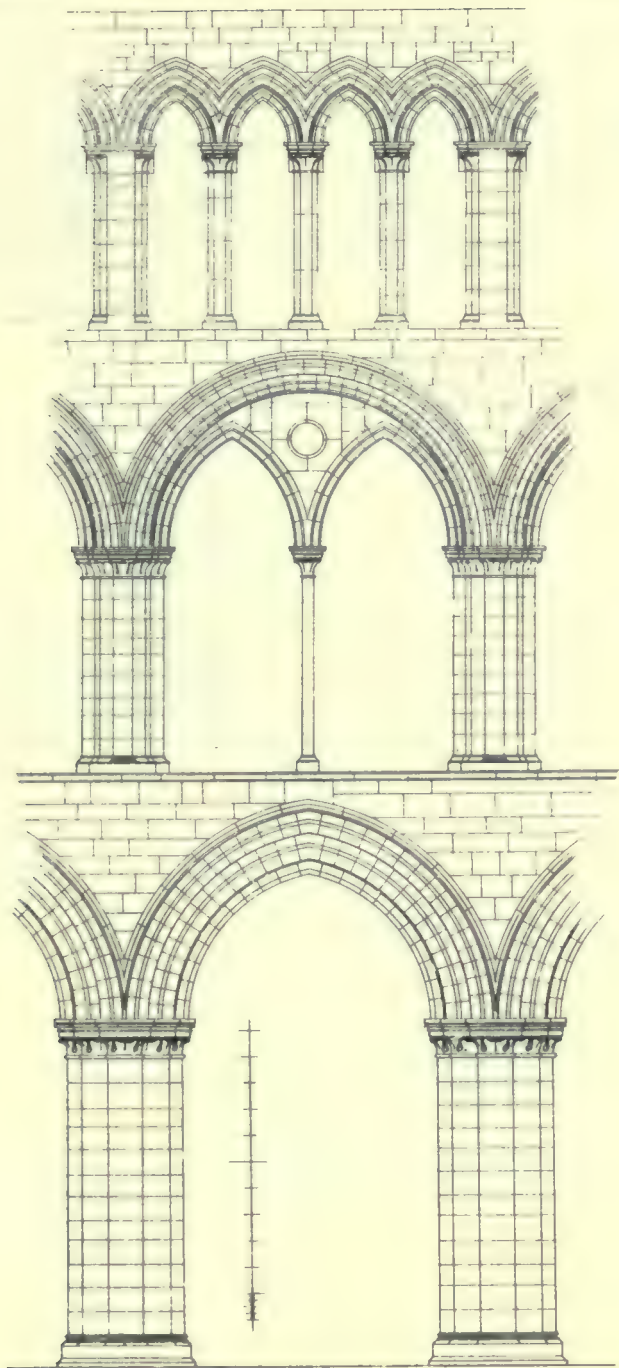
FIG. 370. —Jedburgh Abbey. Details.

In the triforium (Fig. 370) the principal arches are round, being an example of the round arch placed above the pointed arch. Each round arch is divided into two openings by smaller pointed arches, which contain first pointed mouldings (Fig. 371). The larger arches spring from clustered

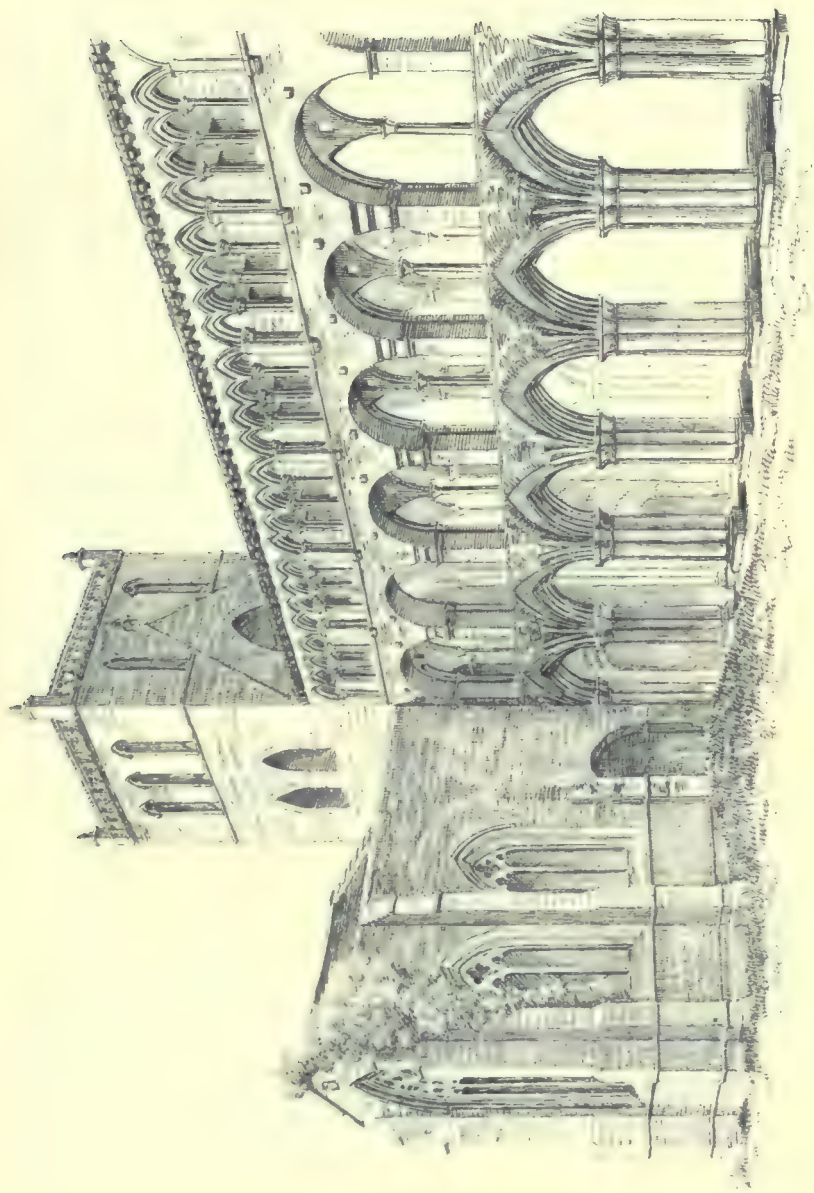
FIG. 372.—Jedburgh Abbey. View from North-West.

shafts with bell caps and square abaci. The central pillars of the smaller arches vary in section. Those in the east part of the nave consist of four shafts united into one (being the same section as those of the clerestory of the choir), while those in the portion of the nave to the west of the centre are composed of two shafts. The shield between the smaller arches is perforated with a small circle. The simple constructional main arches of the triforium are seen on the exterior (Fig. 372), where also the corbels to carry the timbers of the roof of the triforium gallery are visible.

story, and a plain standard in the interior. These buttresses are projected on small corbels, and do not rise above the arches. It is thus evident that it was never intended that the central aisle of the nave should be vaulted, there being no suitable buttresses provided to resist the thrust of a vault. The side aisles, however, were vaulted, but the vaults are now demolished, only some fragments of the ribs being left, as shown in Fig. 372.

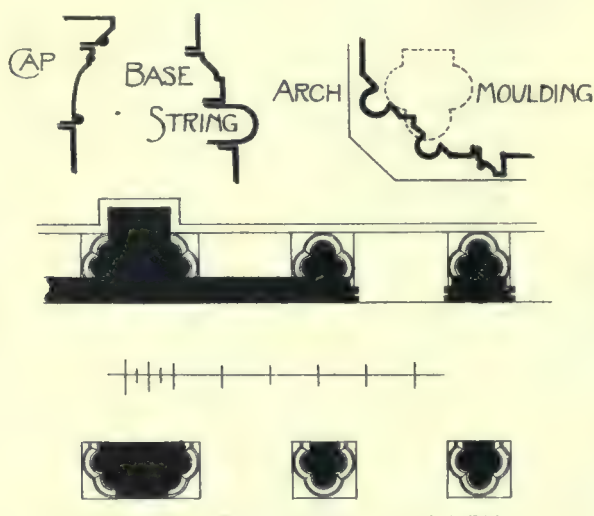
FIG. 373.—Jedburgh Abbey. Clerestory Details.

The clerestory shafts are of trefoil section both on the exterior and interior (Fig. 373), and have foliated caps of first pointed design. In the interior the caps have the angles of the abaci cut off so as to make them octagonal. The arches are all pointed, and contain first pointed mouldings. A corbel table supports the cornice on the exterior, and there are two small ornamental arches between every two corbels (Fig. 374). Over each main pier a small buttress is introduced in the exterior of the clere-

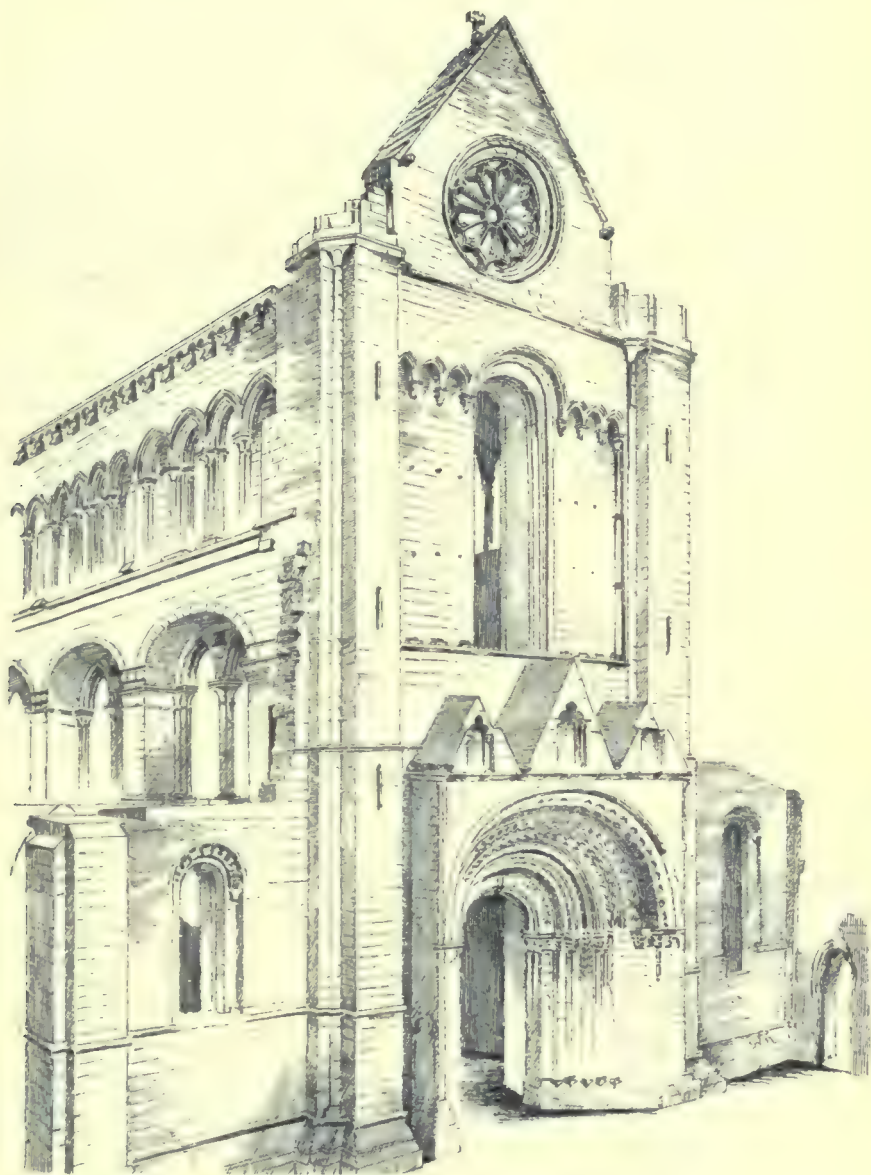
FIG. 374.—Jedburgh Abbey. West End and part of North Side.

As already mentioned, the west end of the nave (see Fig. 374), and especially the western doorway, are quite Norman in character. The west doorway (Fig. 375) is a noble specimen of its period. The ingoing

The jambs of the doorway and the arch over it contain heads and other ornaments in panels, now much decayed. The doorpiece projects some feet, and on the north side of the projection a small round arch (see Fig. 374) can be traced.

The west wall has flat buttresses of Norman character (see Fig. 374) at each side of the central aisle, and the upper portion of the wall has a central round-headed window, flanked on each side by three small pointed arch heads, the caps carrying which rested on long single free shafts, now gone. The central window has deep mouldings, but no enrichment. The west front has been finished with an octagonal turret at each side, as at Kelso Abbey, and the gable contains a central circular window, which has been filled with tracery at a late date. The west end walls of the aisles have each contained a circular headed window of Norman design, with a chevron ornament in the arch and a nook shaft at each side.

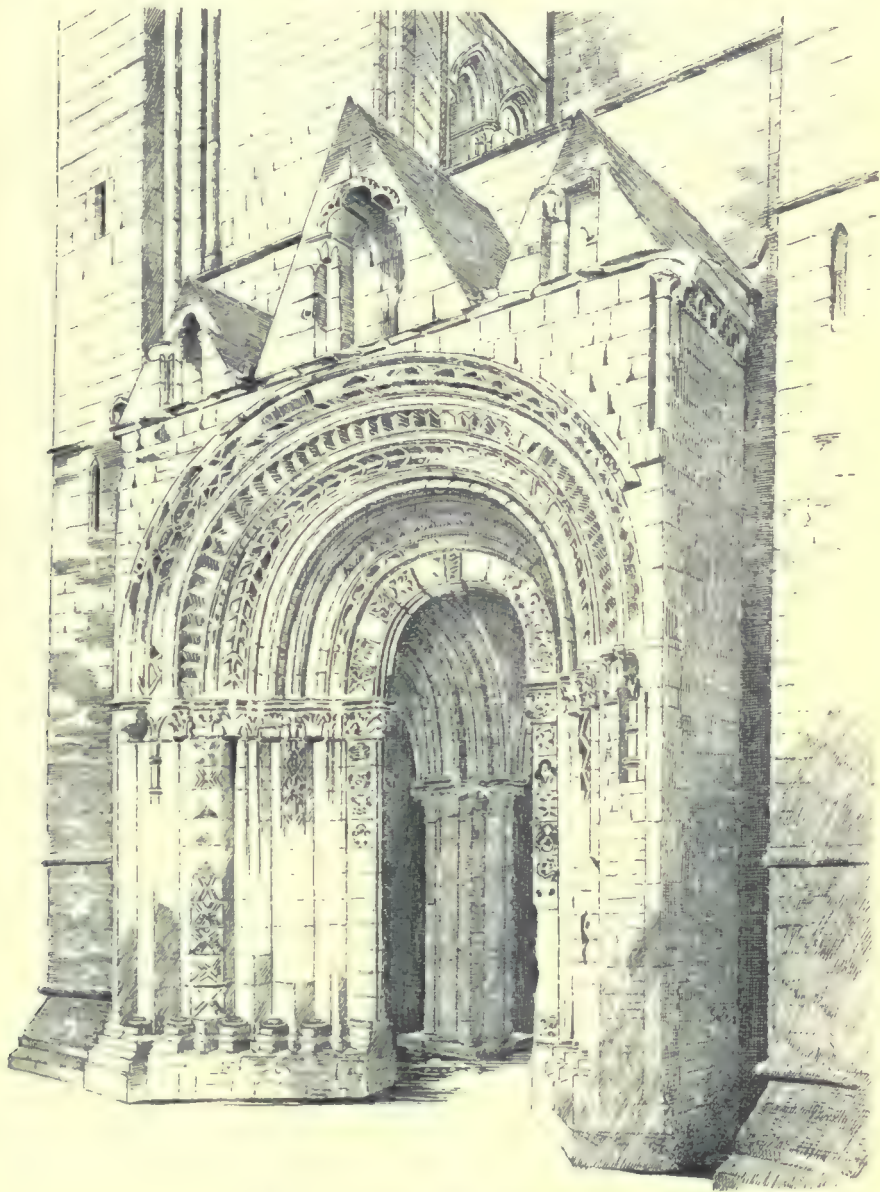
FIG. 375. Jedburgh Abbey. West Doorway.

is deeply recessed, and has contained five free nook shafts on each side, besides the door jamb, with intermediate shafts and elaborate enrichments. The caps are foliated, and of late Norman character. In the arch there is an order over each shaft, and intermediate enrichments and mouldings. The ornaments consist of the chevron, both solid and under cut, and other greatly relieved enrichments and rosettes.

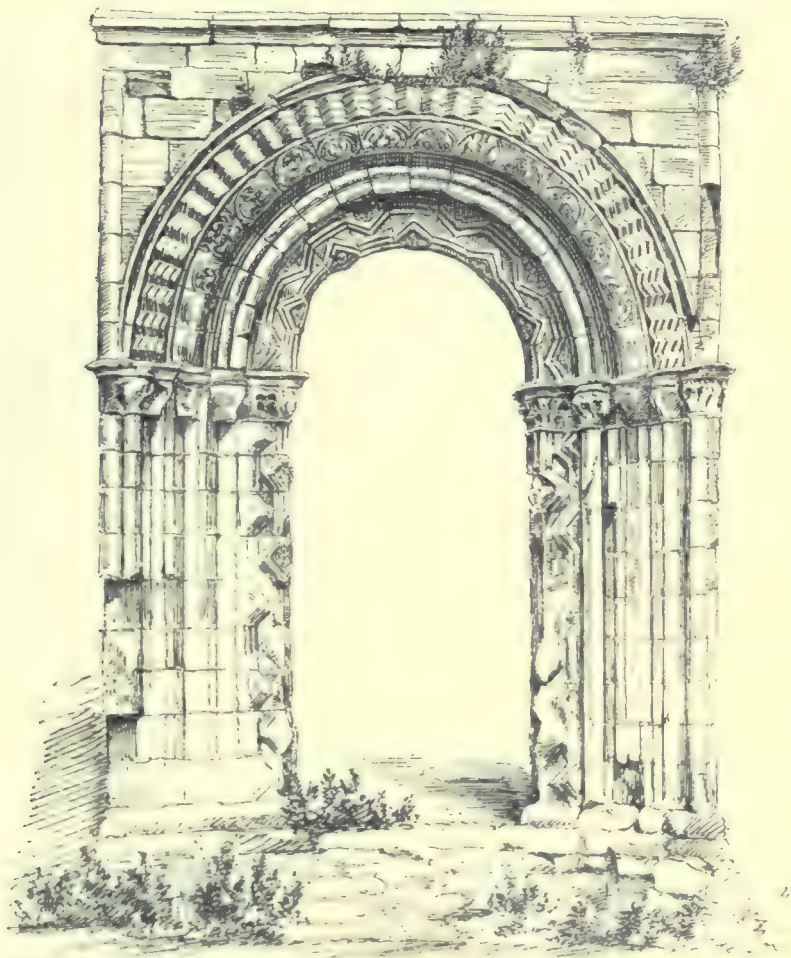
FIG. 376.—Jedburgh Abbey. South Doorway of Nave.

The south doorway (Fig. 376), leading from the cloister into the nave above referred to, is of late Norman design. It is extremely rich in its decoration, though somewhat decayed. It contains the remains of several shafts and enrichments in the jambs, and the caps have been very elaborate in their carving. The round arch head contains four orders of mouldings. The inner order and the door jambs are both carved with the same chevron ornament; the next order consists of plain mouldings; the third order is enriched with figures comprised in small semi-circles; and the outer order contains a deep series of zig-zags. The whole is enclosed with a small label. The doorpiece projects, the outer angle having a bold bead, and a small cornice runs along the top.

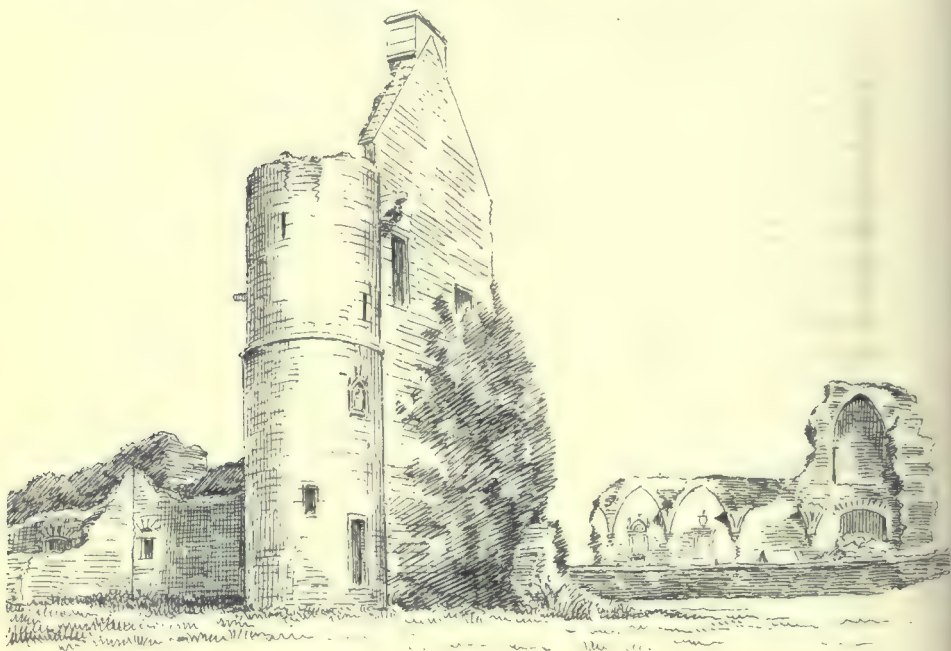
FIG. 377.—Kinloss Abbey. Abbot's House from South-East, and portions of the Church.

There have been vaulted apartments on the south side of the long vaulted chamber lying south of the transept, as is apparent from the remains of pointed arches on the outside of the south wall (see Fig. 377). This sketch also shows the height of the transept chapel above the vault to the south of it. Similar remains of pointed arches on the west side of

The abbot's house (see Figs. 377 and 379) stands to the south of the abbey. It consists of an oblong structure, which now measures about 50 feet in length by 27 feet in width within the walls, with several vaulted cells on each side, all now in ruins, and thickly clothed with ivy. The best preserved parts of the structure are the east wall, with its gable, and the round tower at the south-east angle, which contained the entrance doorway and staircase. Over the doorway is a panel (Fig. 380) with ogee arched head containing the shield of Abbot Reid (a stag's head) and his initials and crozier.

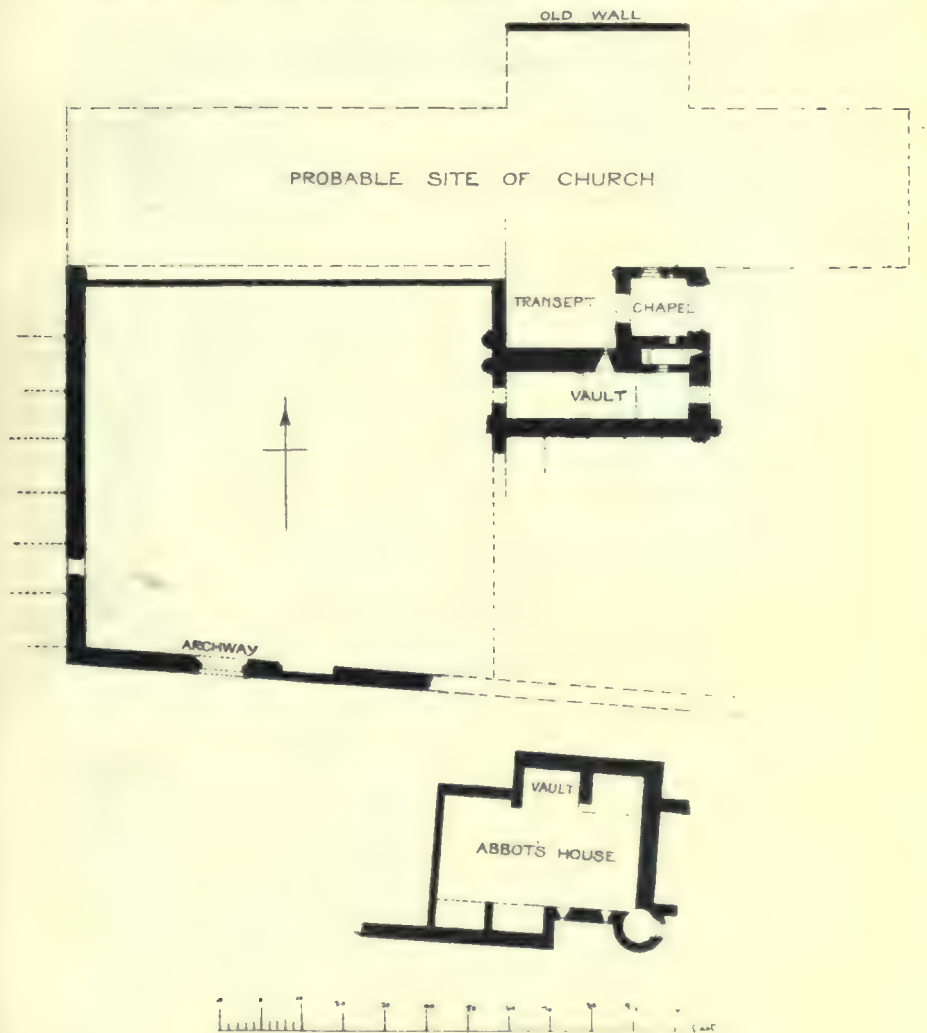
FIG. 378.—Kinloss Abbey. Plan.

From the above cause the remains of Kinloss Abbey, as already mentioned, are mere fragments. The outline of the cloister garth, which measures about 100 feet by 90 feet, can be traced (Fig. 378), the walls on the south and west sides being fairly preserved. On the north side the foundations of what was, doubtless, the south wall of the nave of the church are visible, and on the east side part of the wall of the south transept still stands. Of the church there only survives a small and tottering fragment of the south transept, with part of the eastern chapels and a long vaulted chamber to the south, which is on a lower level than the transept. A small portion of old wall is observable to the north, opposite the south transept, and is probably a survival of the north tran-

sept wall. This gives an indication of the probable position of the church, as shown by dotted lines on the Plan. The church consisted of the usual divisions of nave, choir, and transepts, with a tower over the crossing. The tower was erected by Abbot Guthrie about 1470-80, and it fell in 1574.

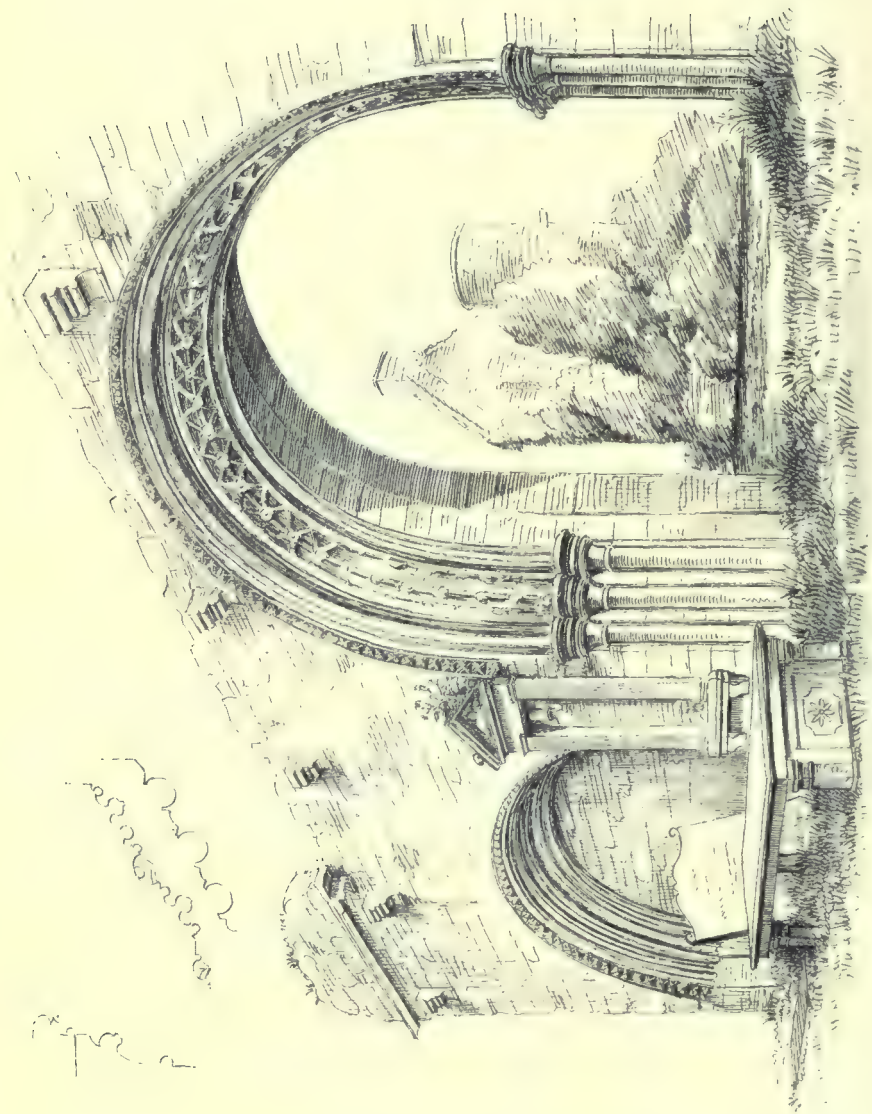
FIG. 379.—Kinloss Abbey. Archway in South Wall of Cloister, and Abbot's House from North-West.

All appearance of ornamental work or hewn work of any kind has been removed, with the exception of one archway in the south wall of the cloister and an arched recess adjoining (Fig. 379). These seem from their style to have been part of the original abbey. The ornament of the gateway is distinctly transitional in character, and was probably erected in the beginning of the thirteenth century. Although the arch is circular, the dog-tooth of the hood mould is first pointed, while the large undercut cross enrichment is a survival of Norman character. The round

abacus of the caps, however, is decidedly first pointed in style. This seems to have been an archway leading into the cloister. The arched recess to the eastward, which was doubtless a monument, is rather later in

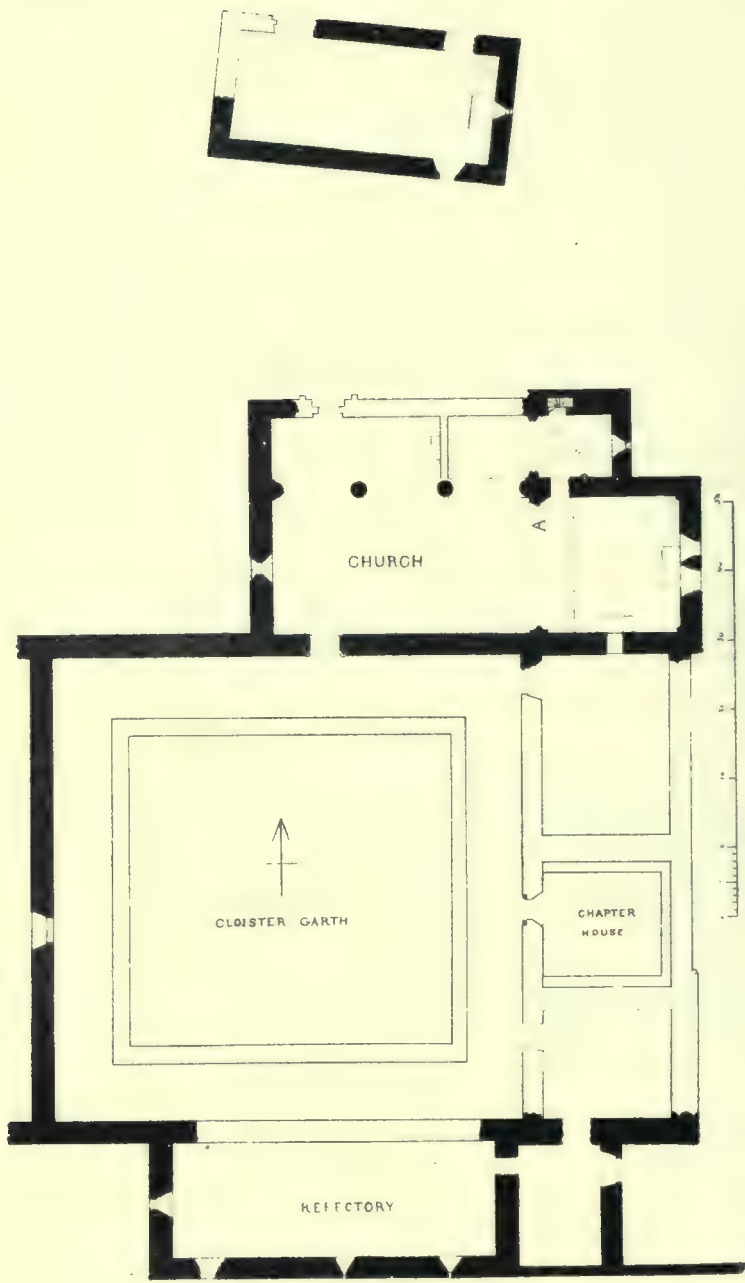
FIG. 381.—The Nunnery, Iona. Plan.

The ruins of the building, which apparently was erected soon after that time, still survive. (Fig. 381.) They consist of a quadrangle about 68 feet square, having the church on the north side; foundations of the chapter house and other apartments on the east side; and the refectory on the south side. There may have been other buildings on the west side, as the walls are broken at the ends; but, if so, they are now removed.

The church is an oblong structure, 58 feet in length by about 20 feet in width. It has been divided into nave and choir, and has had a northern aisle extending along both.

At a distance of about 30 feet north from the convent church stands another building, said to have been the parish church. (See Fig. 381.) It is dedicated to St. Ronan, and is a simple oblong chamber, 37 feet long by 16 feet wide internally.

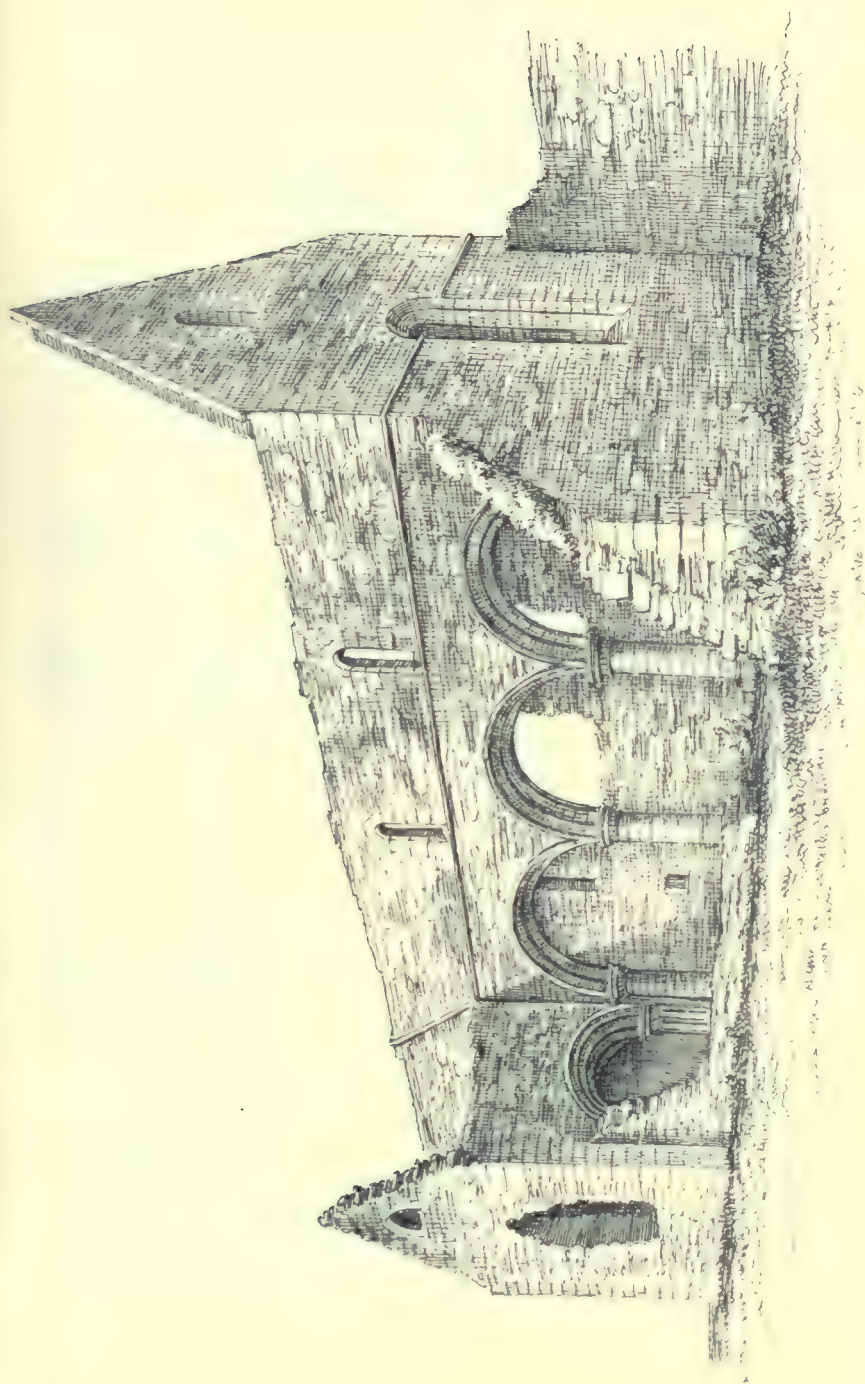
FIG. 884.—The Nunnery, Iona. View from North-West.

The nave has three round arches (see Figs. 383 and 384) opening into the north aisle. These arches spring from circular pillars and responds, which have caps of apparently Norman design. They are much decayed, but the ornament has some resemblance to that of the caps in the chapter house and high aisle of the cathedral. The arches are now built up, but the mouldings seem to correspond with those of the chancel arch. The doorway from the cloister, in the south-west angle of the church, has two nook shafts supporting a round arch.

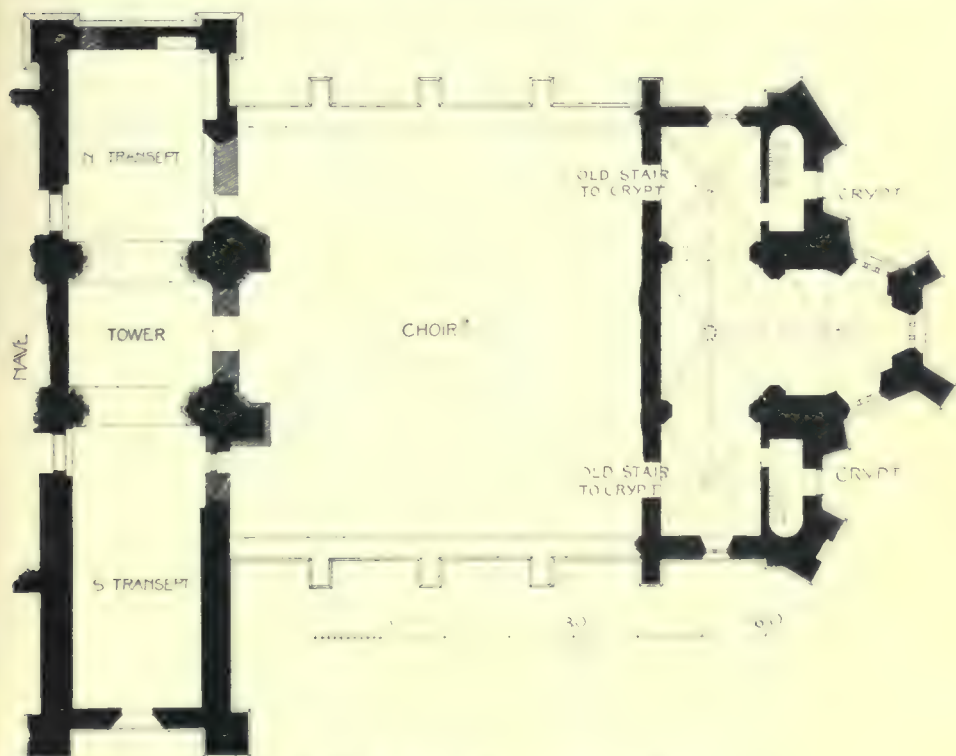
FIG. 385.—St. Nicholas' Church, Aberdeen. Plan.

The transepts (Fig. 385) measure internally about 103 feet by 20 feet 10 inches, and are of the transitional style of the end of the twelfth century. The openings into the nave and choir are now built up. There

The crypt at the east end of the choir is shown on Plan in its proper relation to the transepts, but it is on a lower level. Although, as already stated, no part of the choir now remains, the walls drawn in outline are

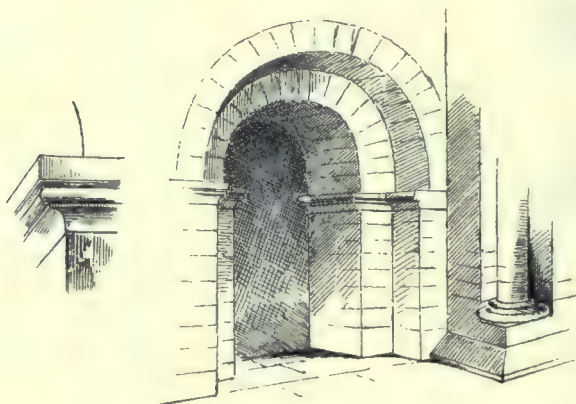
FIG. 386.—St. Nicholas' Church. Doorway between Transept and Nave Aisles.

seems always to have been a solid wall between the transept and the nave aisles, with only a small opening of communication in each of about the size of an ordinary doorway. These openings are of a very plain and simple design (Fig. 386). The piers which carry the central tower (Fig. 387) are of the usual transitional type, having graceful capitals and square abaci supporting round arches. These are shown in detail in Fig. 388. They are not visible in the choir and nave.

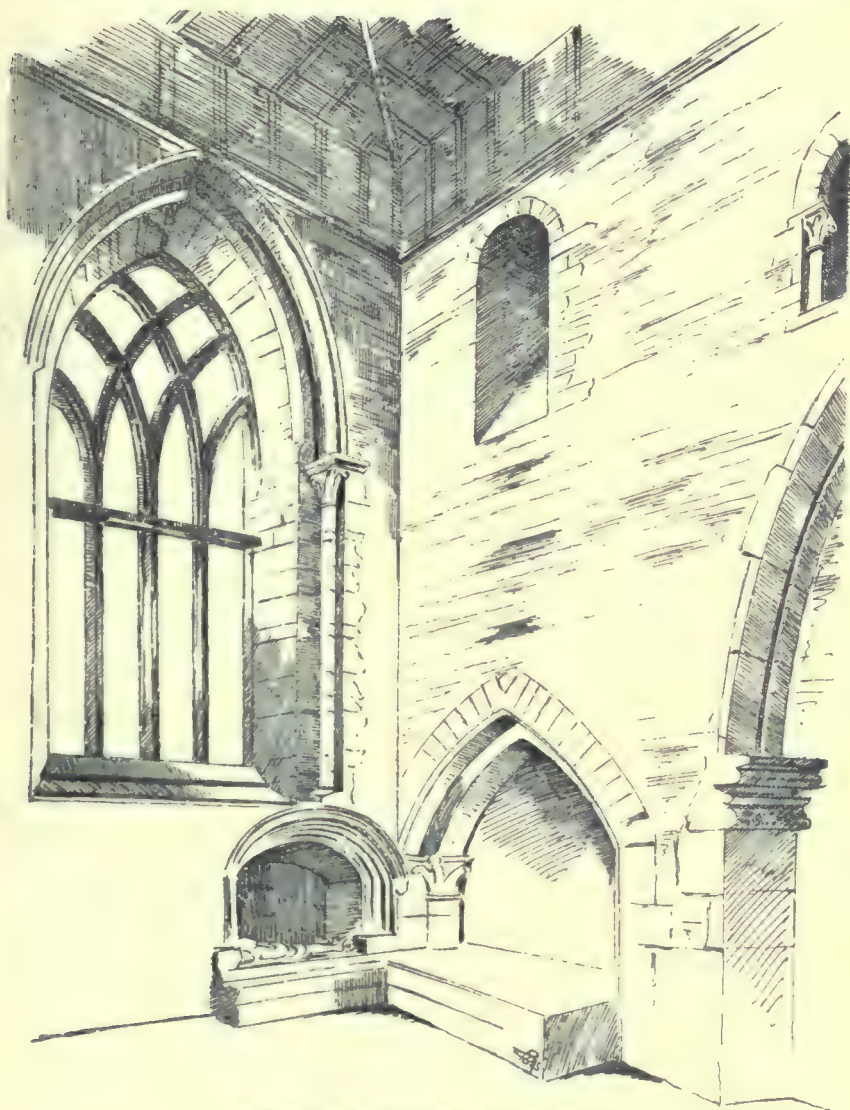
FIG. 389.—St. Nicholas' Church. North Transept.

windows, those on the east side are seen in Fig. 389, and one of them, which would overlook the roof of the choir aisle (Fig. 390), has angle shafts, with carved caps and mouldings. The present large north window of the transept (seen in Fig. 389), the tracery of which is of very late work, has remains of its original features, and in the low pointed recess seen in the same view there is a transition attached shaft, with carved cap and square abacus. There is only a shaft on one side of the recess (as shown on Plan). The pointed arch of this recess, as well as the tomb alongside, below the large window, are of later work.

The "fair wyndo" is, doubtless, the window in the north end wall just referred to as having been altered, and seen in Fig. 389. The foregoing are the only original features of the upper church now remaining, all else is of the fifteenth and following centuries, and consists generally of the wide pointed openings leading into the choir; and in the south transept of a fifteenth century sculptured tablet of fine design (Fig. 391) with the following modern inscription beneath—"The above stone represents the Chantry or Annual Mass to be sung for his soul. Founded by William Leith, of Barns, Provost of Aberdeen in 1351, who, with many of his Descendants, is Interred underneath." The monument has had an inscrip-

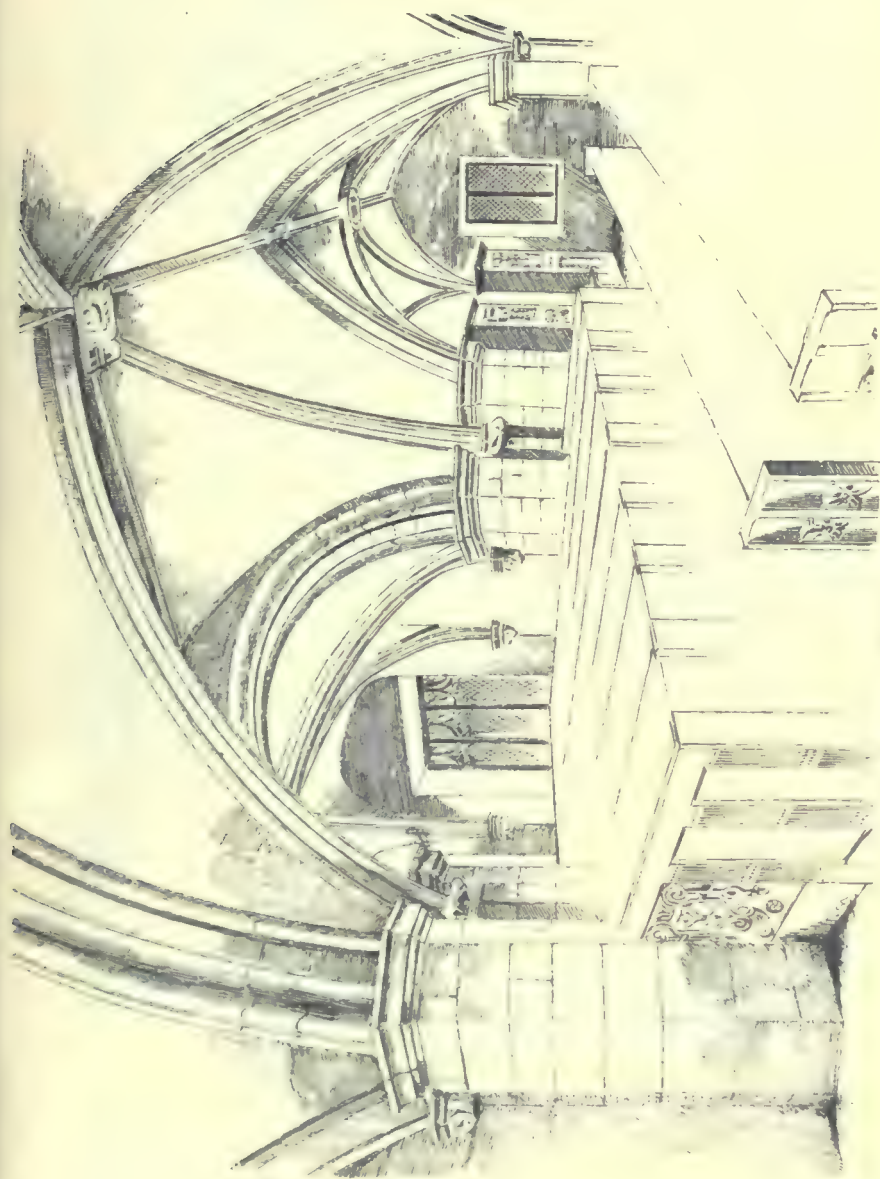
FIG. 322.—St. Nicholas' Church. Crypt, looking South-East.

The roof is groined throughout, the three compartments in the length (Fig. 392) being separated by pointed arches, which spring from moulded caps on octagonal responds. The ribs are the same in all

through these caps and rest on the notch formed in the centre of the wide diagonal respond at the opening to the apse (see Fig. 392).
